# CONSTRUCTION CONTROL AND APPLICATION OF PRECAST CONCRETE INCLINED SQUARE PILES

**Abstract:** Precast concrete inclined square piles are widely used in foundation pit support engineering, but their construction is easily affected by factors such as geological conditions, technological complexity, and on-site management, resulting in various quality defects. This article, based on actual engineering cases, systematically analyzes the common types of quality defects in the construction of precast concrete inclined square piles, explores the causes of these defects in depth, and proposes corresponding countermeasures to provide technical reference for similar projects and improve construction quality and engineering safety.

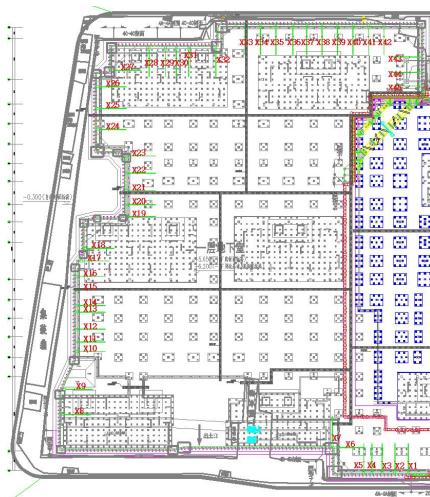
**Figure 2** Detailed Diagram of Inclined Pile Distribution

The original design for this foundation pit project included 45 inclined square piles, distributed sequentially on the first floor of the basement, serving as support and maintenance in conjunction with HC method piles. The inclined square

piles (solid square piles) were factory-precast, with a concrete strength grade not lower than C30. HRB400 steel reinforcement was permitted, with a minimum protective layer thickness of 20mm for the main reinforcement and an allowable error of no more than 5mm. The original design specified a pile length of 15m and a concrete strength not lower than C30. (Figure 2)

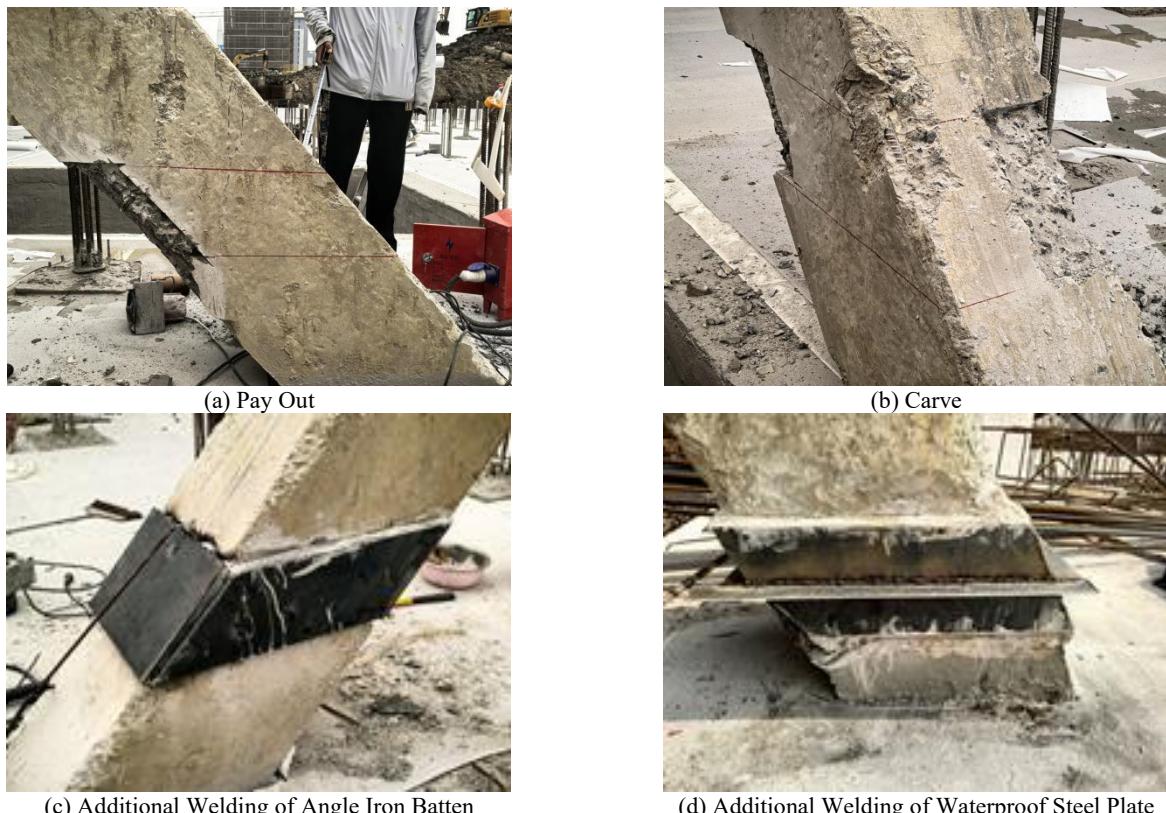
**Figure 3** Rectification Measures

A 50mm×4mm waterstop steel plate will be welded around the center of the inclined square pile penetrating the base slab. Angle steel (4L140×14) will be used for fixation, ensuring a tight weld free of air bubbles. During the welding process, care must be taken to protect the waterstop membrane of the base slab, and damage to the waterproof membrane caused by welding is strictly prohibited. (Figure 3).

The original design stipulated that the precast waterstop steel plates should be located in the center of the floor slab after the construction of the inclined square piles. However, due to factory design and on-site construction precision issues, the precast waterstop steel plates did not reach the original design elevation (as shown in Figures 6 and 7), and the elevation errors were all greater than 1500 mm.
